NASA/TP-97-206257

The Characteristics of Fatigue Damage in the Fuselage Riveted Lap Splice Joint

Robert S. Piascik
Langley Research Center, Hampton, Virginia

November 1997

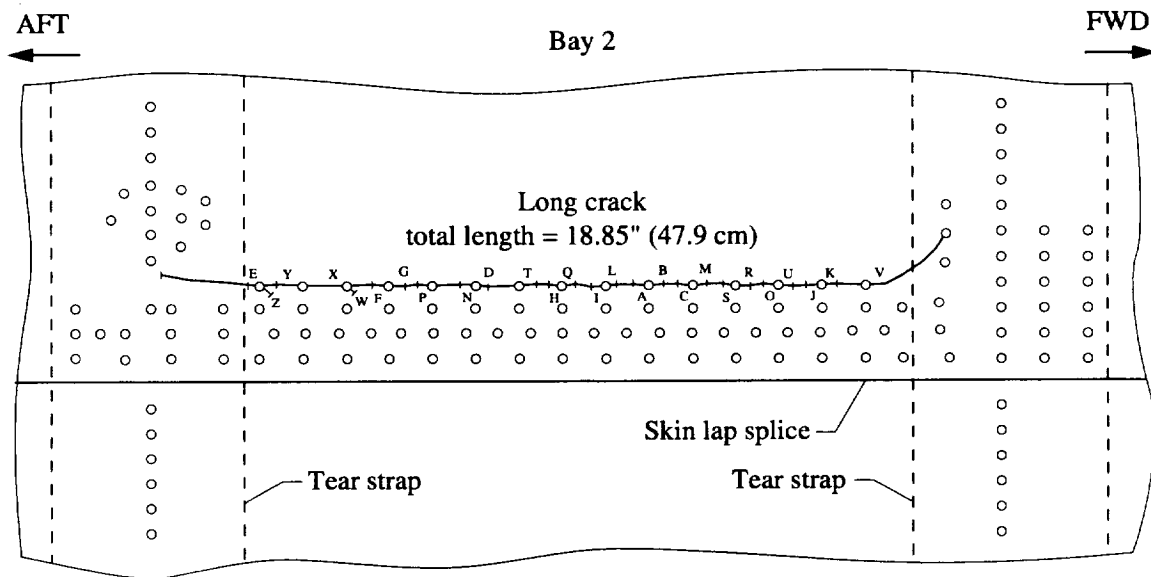
Figure 3.1 shows a schematic of bay 2 detailing the locations of the lap splice rivet holes, the tear straps and the 18.85 inch (47.9 cm) upper rivet row crack. It should be noted that the schematics shown in this section are used to show general features; the drawings (not drawn to scale) show the approximate rivet hole locations. More accurate drawings of the rivet hole spacings are found in Sections 6.0 through 11.0. As fatigue cracks were visually observed during the pressurization test, the sequence of outer skin fatigue cracking was identified alphabetically. The letters A through Z shown in Figure 3.1 therefore identify the chronology of fatigue cracking within the bay. Figures 3.2 and 3.3 are photographs showing the appearance of the outboard skin surface of bays 1 and 2, respectively. Open holes remain where rivets were removed after pressure testing and prior to receipt of the panel. The numbers located above each of the upper rivet holes are used to identify specific rivet locations within each bay. The large crack is easily visible along the entire upper rivet row in bay 2 and extending into both tear straps. Figures 3.4, 3.5 and 3.6 are more detailed photographs of the large upper rivet row crack observed in bay 2. Each fatigue crack segment is identified per the chronological code (A through V) shown in Figure 3.1.³ From Figures 3.4, 3.5 and 3.6, the following observations are made.

Figure 3.1 The schematic shows bay 2 and two adjacent tear strap regions. Dashed lines mark the location of the tear straps. The "tic" marks locate the approximate location for fatigue cracks A through Z prior to link-up. The long crack is shown along the upper rivet row.

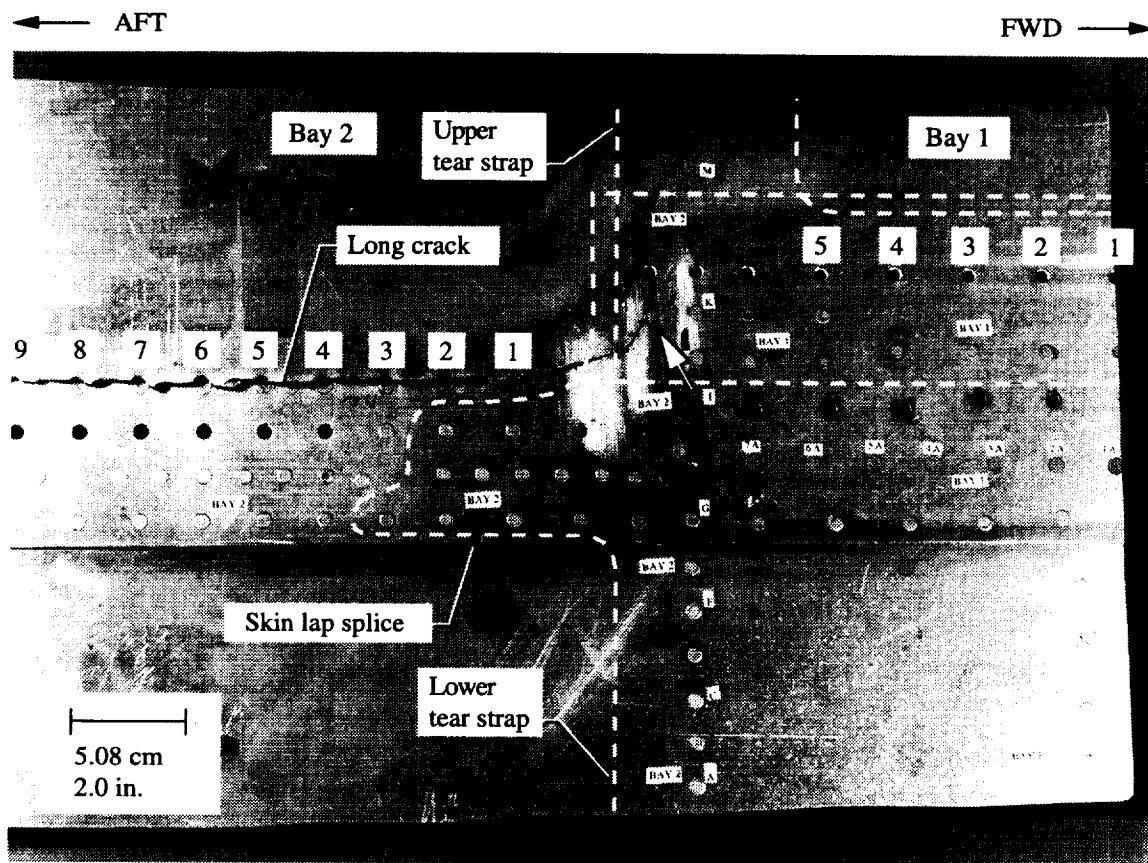
Figure 3.2 The photograph shows the bay 1 tear strap region and a portion of bay 2. The complex shape of the bay 1 tear strap is shown by the dotted lines. The bay 2 long crack is clearly visible along the upper rivet row of the midbay section. Growth of the forward portion of the bay 2 crack terminated at a rivet hole in the bay 1 tear strap region (arrow). Rivet rows are labeled with letters (bottom to top) and rivet holes are numbered from forward to aft (right to left). Note: A number of rivets were removed for visual and within hole eddy current inspection prior to receipt of the panel.

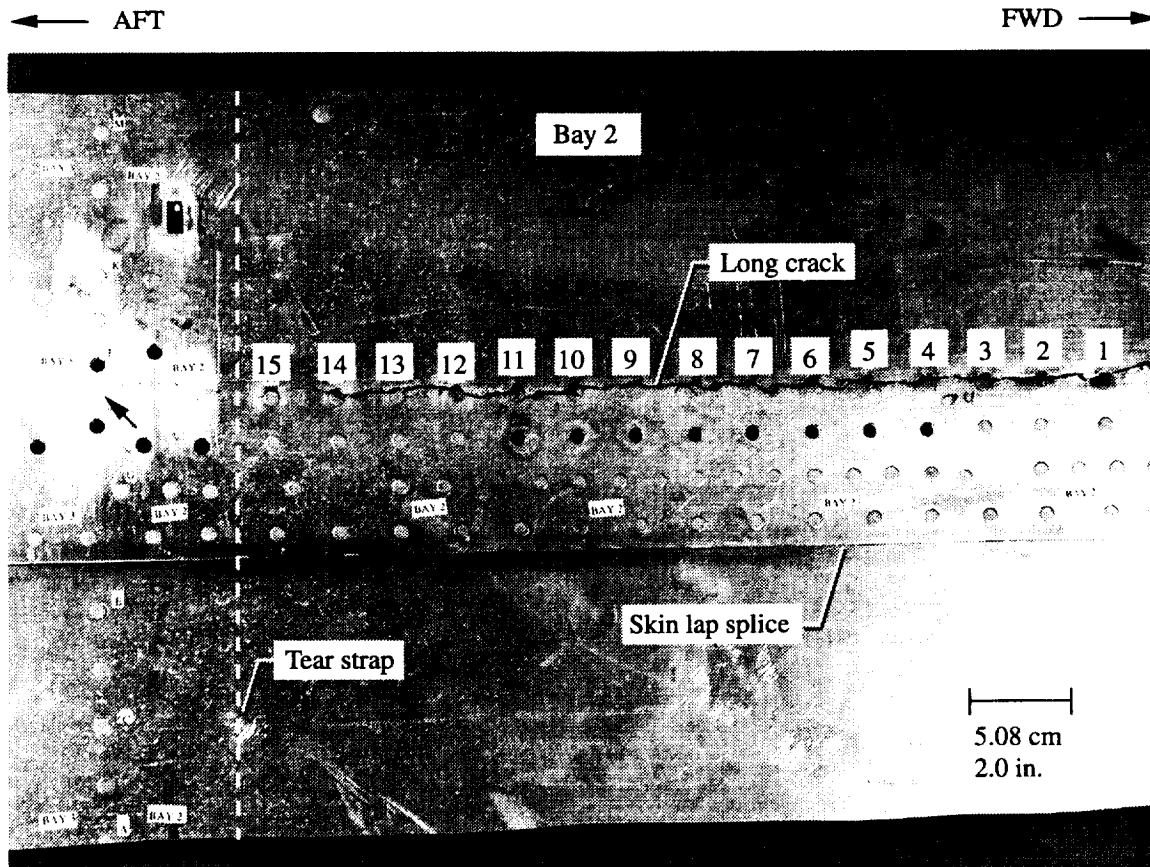
Figure 3.3 The photograph shows bay 2 and the bay 2/3 tear strap region (left of the dotted line). The long bay 2 crack is visible along the upper rivet row. Growth of the aft portion of the bay 2 crack terminated in the 2/3 tear strap region. Rivet rows are labeled with letters (bottom to top) and rivet holes are numbered from forward to aft (right to left). Note: A number of rivets were removed for visual and within hole eddy current inspection prior to receipt of the panel.

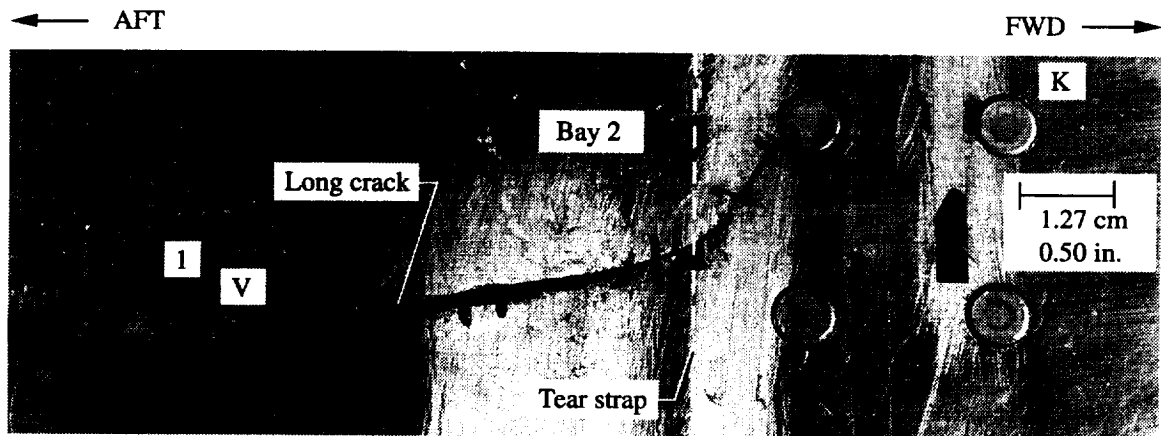
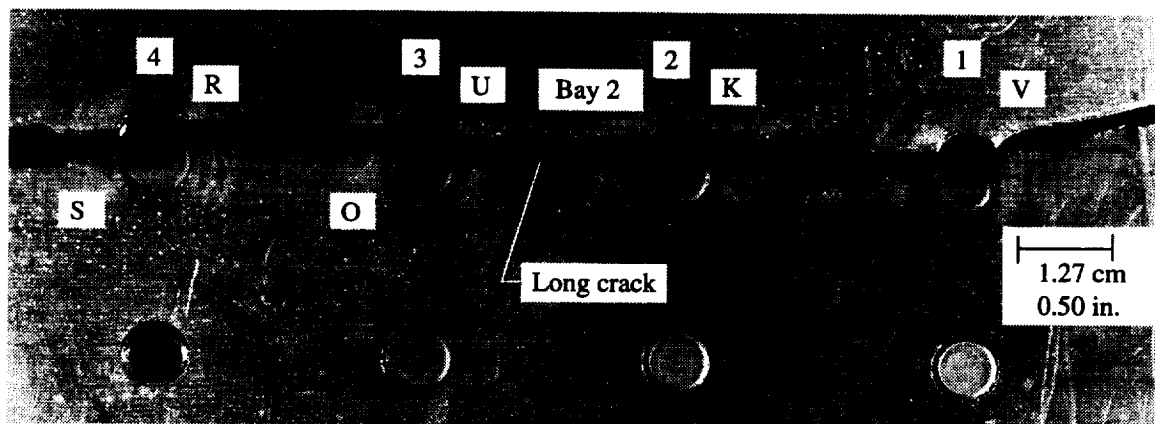
1. All visible fatigue cracking was contained in the upper rivet row.
2. Each fatigue crack initiated at or above the mid plane (centerline) of the rivet hole.

Figure 3.4 a) The photograph shows the forward end of the long bay 2 crack. Growth of the forward end of the crack terminated in a row K rivet hole contained in the bay 1 tear strap region (dashed line). The position of the fatigue crack front, detected by *in situ* visual observation, is noted by the arrow at position V. b) The photograph shows upper rivet holes 1 through 4 and a portion of the long bay 2 crack. Arrows mark the position of fatigue crack fronts detected by *in situ* visual observations at positions S, R, O, U, K, and V.

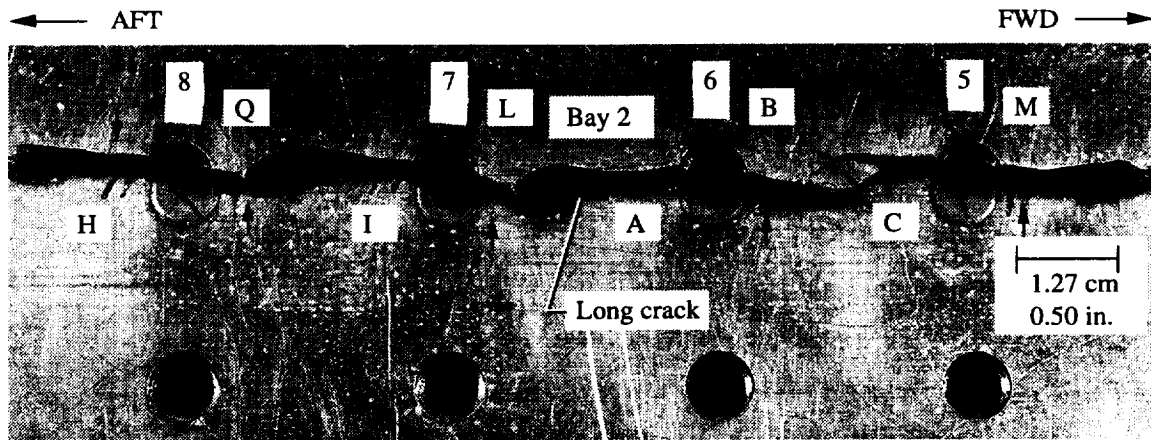
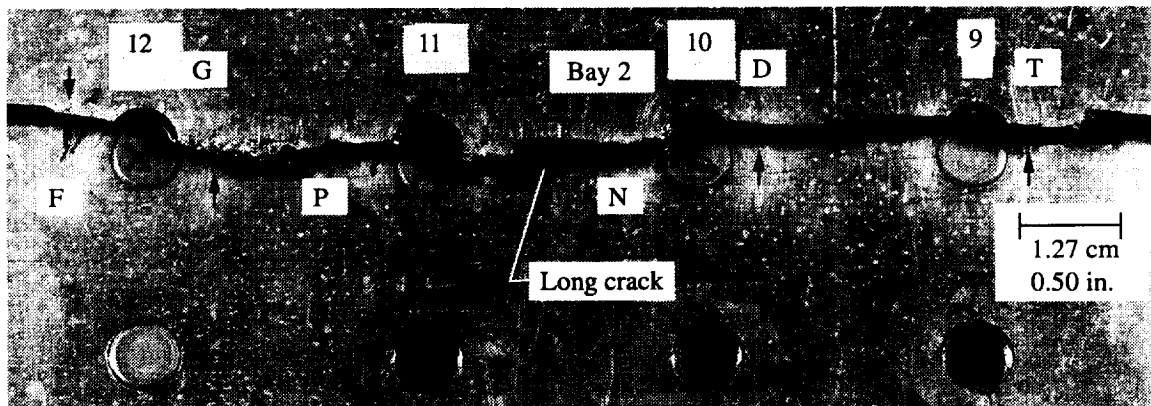
3. The region of fatigue cracking between rivet holes 5, 6, and 7 in Figure 3.5 was the first region of crack link-up in bay 2, refer to Figure 2.1. These fatigue cracks exhibit a characteristic curved crack path that resulted in an oblong shaped crack link-up configuration. Cracking at other bay 2 rivet hole locations exhibited a straighter crack path.

4. The upper portion of the rivet head contained in holes 2, 4, 5, 8, 10, 11, 12, and 14 were severed during pressure testing. As the crack link-up process proceeded from holes 5, 6, and 7, increased out-of-plane loads resulted in the fracture of the upper portion to the rivet head, allowing out-of-plane loading (Mode III). Presumably, Mode III loading increased as subsequent crack link-up had occurred. The outer skin below the long crack was captured by the rivet head and showed no evidence of outward deformation (pillowing).

Figure 3.5 a) The photograph shows upper rivet row holes 5 through 8 and a portion of the long bay 2 crack. The position of fatigue crack fronts, detected by *in situ* visual observations, are noted by arrows at positions H, Q, I, L, A, B, C, and M. b) The photograph shows upper rivet holes 9 through 12 and a portion of the long bay 2 crack. The position of fatigue crack fronts, detected by *in situ* visual observations, are noted by arrows at positions F, G, P, N, D, and T.

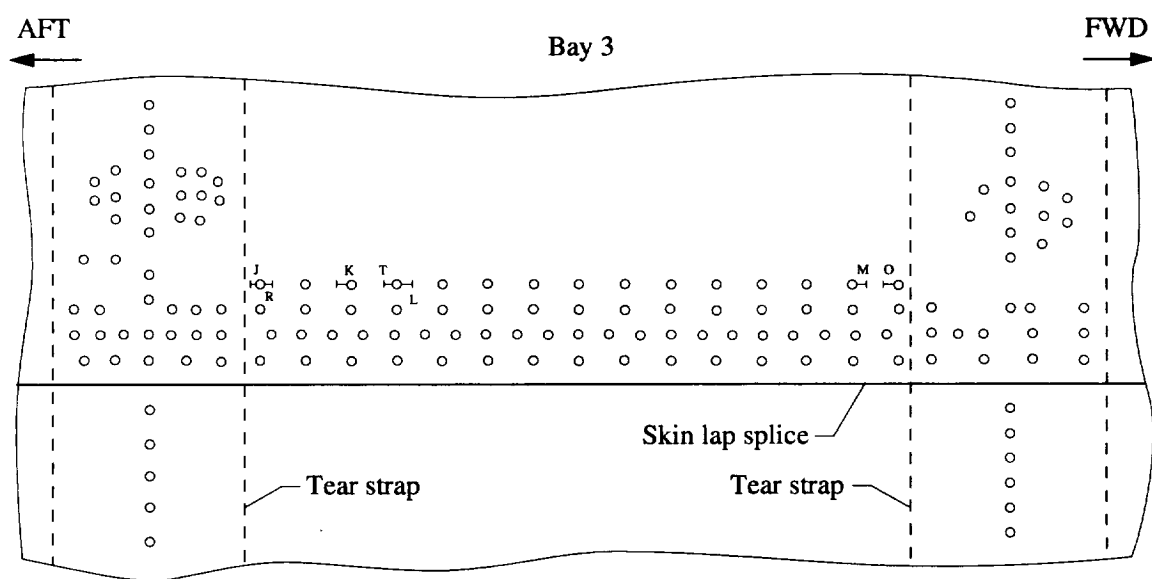
Figures 3.7 and 3.8 show the configuration and overall condition of bay 3 outer surface. Note that all top row and six second row rivets were removed prior to receipt of the panel. Figure 3.9 shows the outer skin surface region that contain visible fatigue cracks adjacent to upper rivet holes 1 through 4 and 12 through 15. Visible fatigue cracks were observed at locations J, K, L, M, O, R, and T. No crack link-up was visible in bay 3. Figure 3.10 is a photograph of the tear strap region that separates bays 3 and 4. No visible evidence of outer skin cracking was observed with the bay 3/4 tear strap.

Figure 3.7 The schematic shows bay 3 and the two adjacent tear strap regions. Dashed lines show the location of the tear straps. Shown are the locations of fatigue cracks, J, K, L, M, O, R, and T.

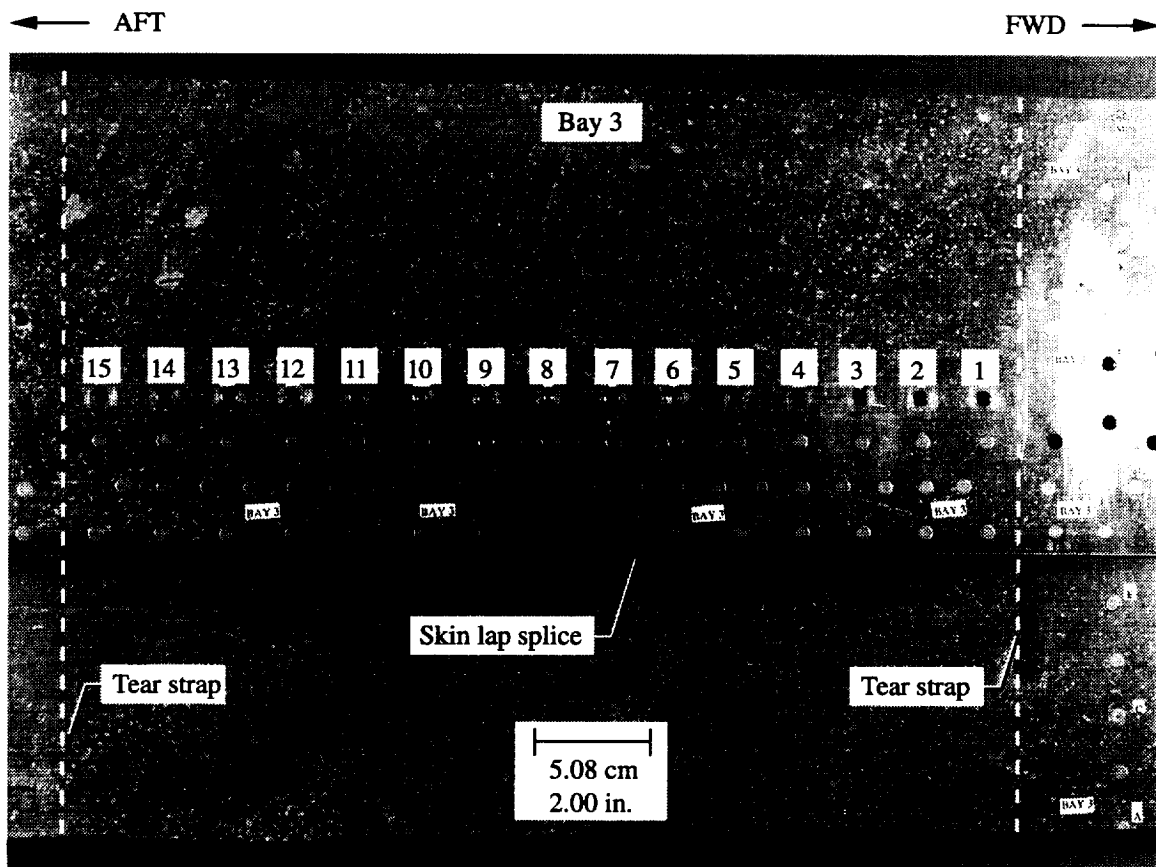
Figure 3.8 The photograph shows bay 3 and portions of the bay 3/4 and bay 2/3 tear strap regions (marked by dashed lines) to the left and right of the photograph, respectively. Rivet rows are labeled with letters (right) from bottom to top (A through M) and rivet holes are numbered from forward to aft (right to left).

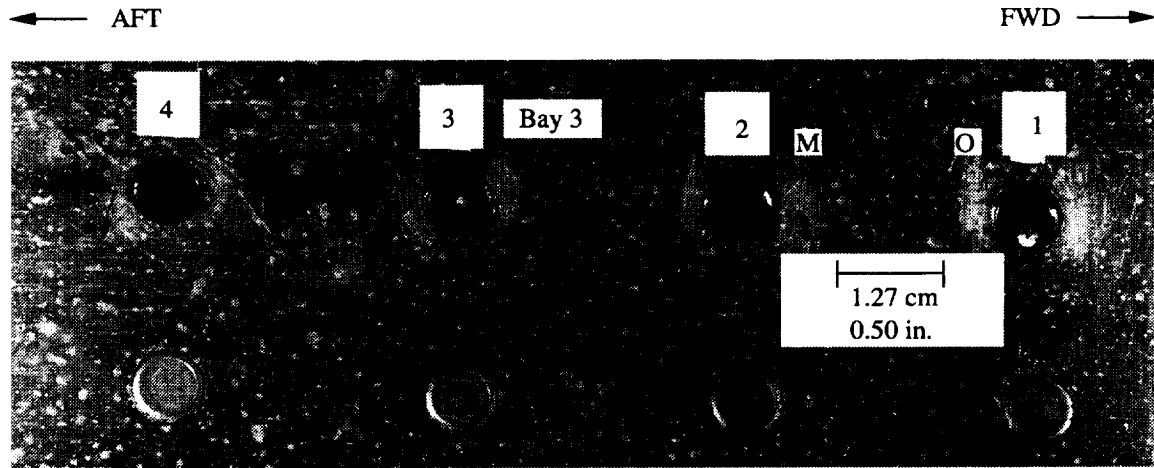
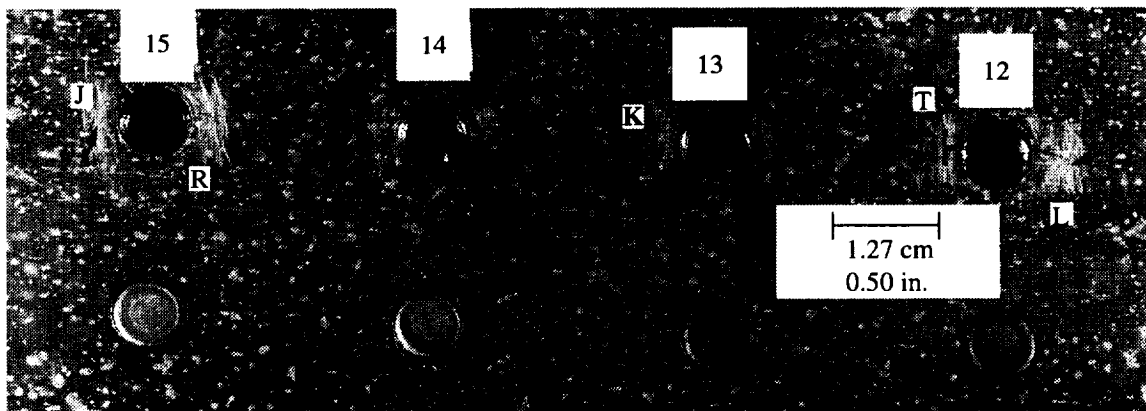
Figure 3.9 a) The photograph shows bay 3 upper rivet row holes 1 through 4. The position of fatigue crack fronts, detected by *in situ* visual observations, are noted by arrows at positions M and O. b) The photograph shows bay 3 upper rivet row holes 12 through 15. The position of fatigue crack fronts, detected by *in situ* visual observations, are noted by arrows at positions J, R, K, T and L.

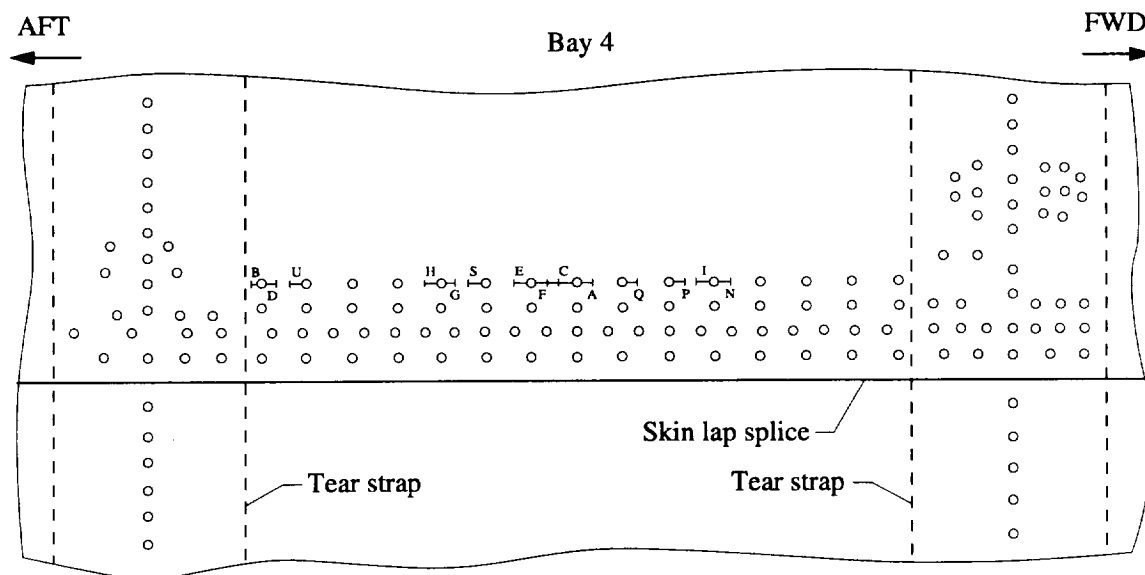
The schematic in Figure 3.11 and the photograph in Figure 3.12 show the location of fourteen fatigue cracks contained in nine upper rivet row holes. Crack link-up occurred in the middle of the bay between upper rivet row locations 8 and 9. Figures 3.13 and 3.14 are photographs of the outer surface showing the visible fatigue cracks along the upper rivet row. Figure 3.13b details the region of crack link-up, cracks F and C. Crack C propagated within a plane slightly elevated with respect to crack F. Link-up occurred at a point located nearly mid-distance between the rivet holes 8 and 9. Final link-up occurred by the failure of the small ligament located between the two fatigue cracks C and F, producing a crack at an angle nearly 30° from vertical.

Figure 3.11 The schematic shows bay 4 and two adjacent tear strap regions. Dashed lines show the location of the tear straps. The location of thirteen fatigue cracks are noted at A, B, C, D, E, G, H, I, N, P, Q, S, and U. Crack link-up occurred between fatigue cracks C and F.

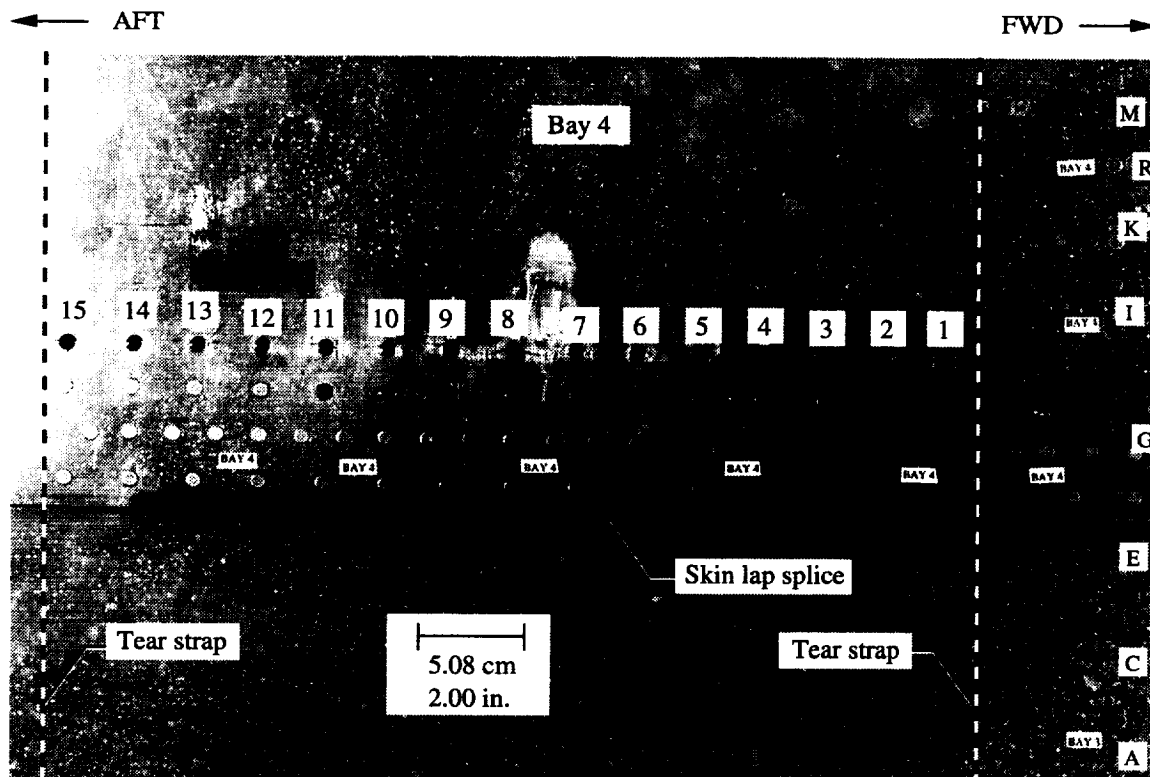
Figure 3.12 The photograph shows bay 4 and portions of the bay 4/5 and bay 3/4 tear strap regions (dashed lines) that are visible to the left and right of the photograph, respectively. Rivet rows are labeled with letters (right) from bottom to top (A through P) and rivet holes are numbered from forward to aft (right to left).

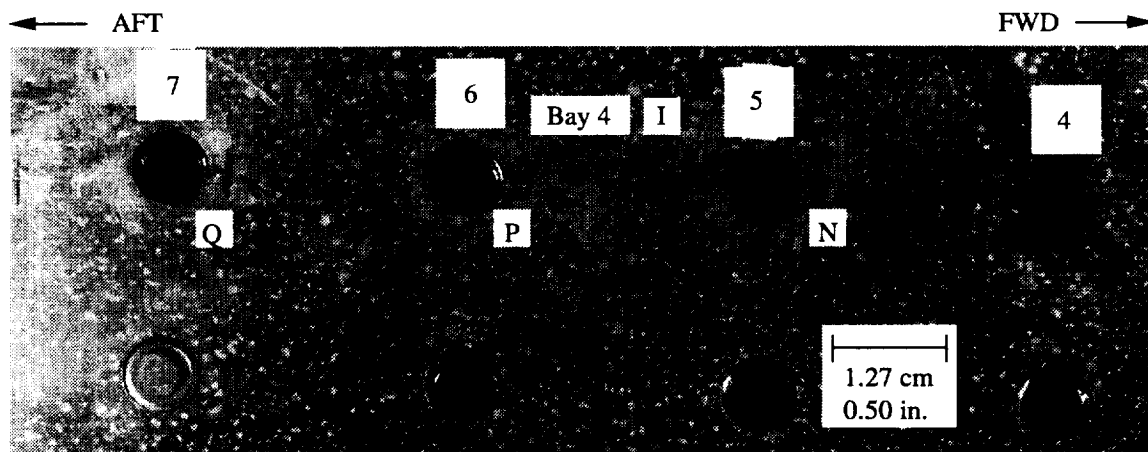
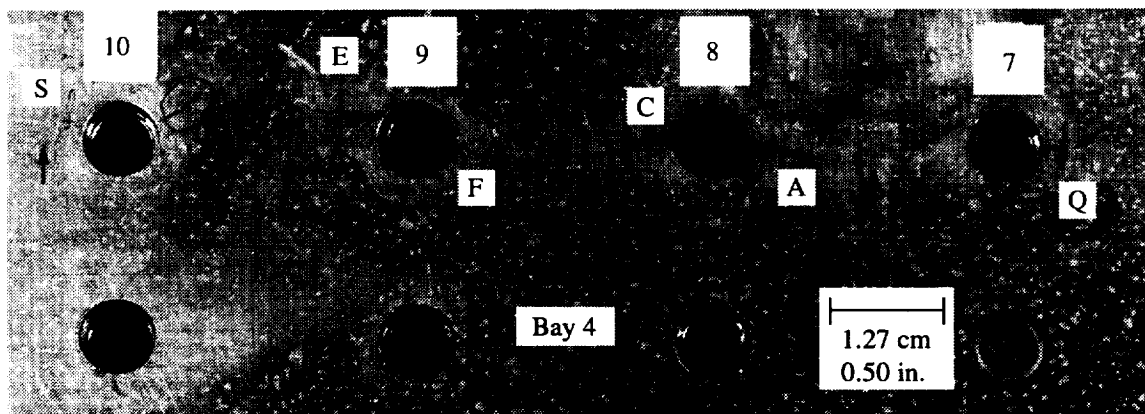
Figure 3.13 a) The photograph shows bay 4 upper rivet row holes 4 through 7. The position of fatigue crack fronts, detected by *in situ* visual observations, are noted by arrows at positions Q, P, I, and N. b) The photograph shows bay 4 upper rivet row holes 7 through 10. The position of fatigue crack fronts, detected by *in situ* visual observations, are noted by arrows at positions S, E, F, C, A, and Q. The cracks between rivet holes 8 and 9 have linked-up.

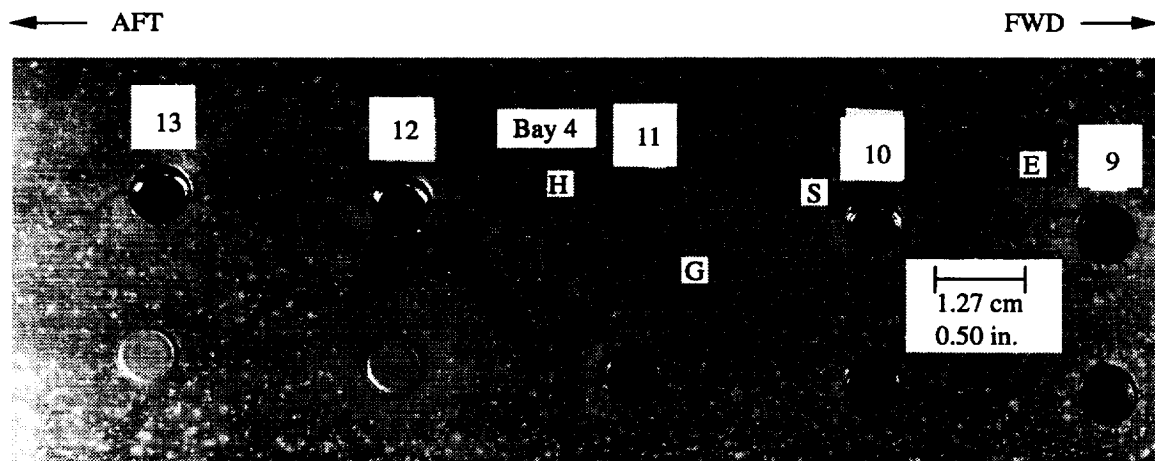
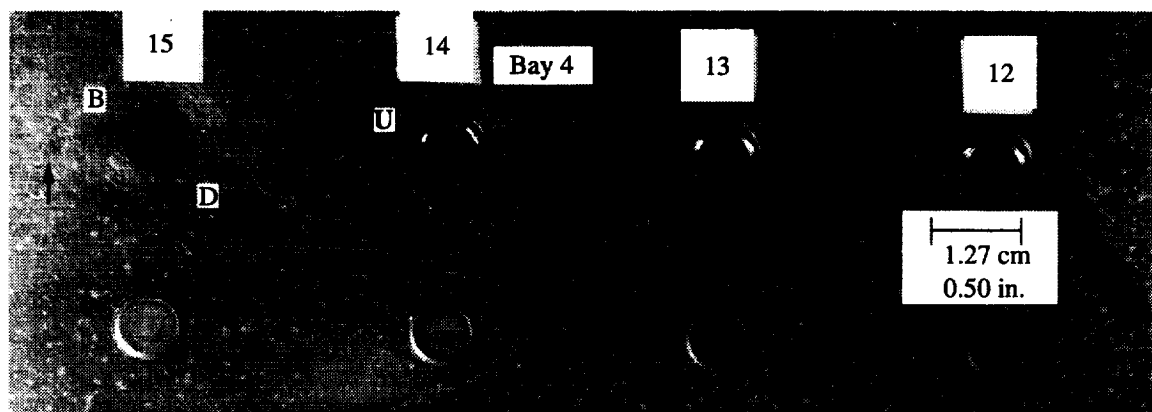
Figure 3.14 a) The photograph shows bay 4 upper rivet row holes 9 through 13. The position of fatigue crack fronts, detected by *in situ* visual observations, are noted by arrows at positions H, G, S, and E. b) The photograph shows bay 4 upper rivet row holes 12 through 15. The position of fatigue crack fronts, detected by *in situ* visual observations, are noted by arrows at positions B, D, and U.

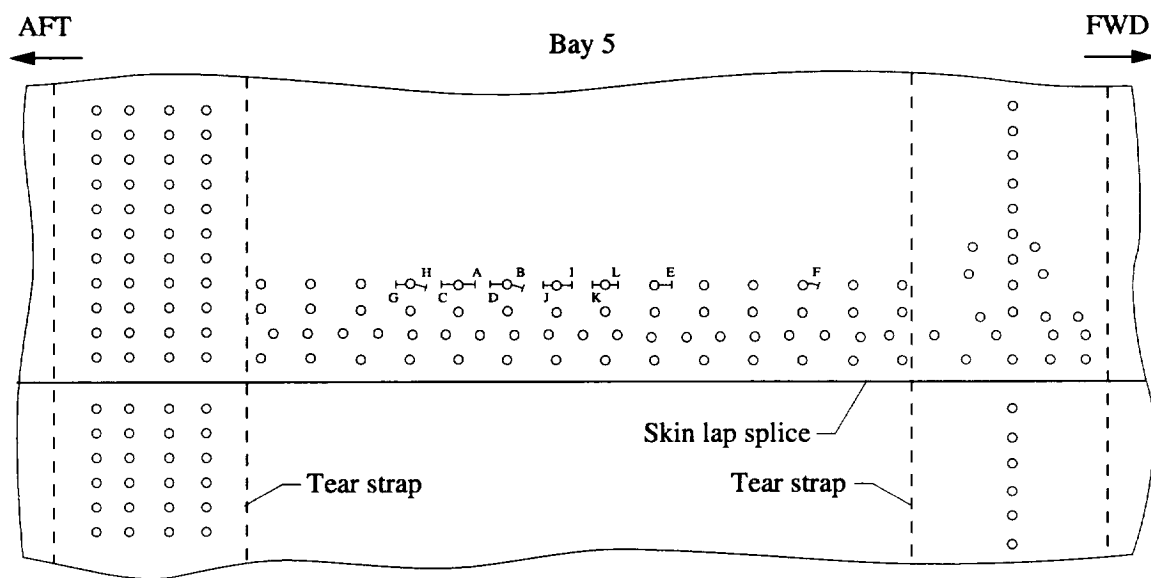
Figure 3.15 shows the rivet hole configuration for bay 5. Here, seven upper rivet holes contained a total of twelve visible fatigue cracks. No visible fatigue crack link-up was observed in bay 5. The photographs in Figures 3.16 and 3.17 shows the outboard surface of bays 4 and 5 and the tear strap regions bordering bays 5 and 6, respectively. Figures 3.18 and 3.19 are photographs detailing the visible cracks found in bay 5 upper rivet row. Figure 3.19 shows the crack path between upper rivet holes 7, 8, 9, and 10. All fatigue cracks that propagated in the forward direction exhibited a curved crack path slanted upwards and fatigue cracks that grew in the aft direction curved downwards. Many of the fatigue cracks shown in Figure 3.19 extend close to the adjacent rivet hole without crack link-up. A number of the aft fatigue cracks, i.e., crack C in hole 10, initiated below the mid plane of the rivet holes. This crack path configuration differs from that observed in bays 2, 3, and 4 and suggest the possible influence of complex loading created by nearby structure.

Figure 3.15 The schematic shows bay 5 and two adjacent tear strap regions. Dashed lines highlight the location of the tear straps. Shown are the locations of fatigue cracks A through L.

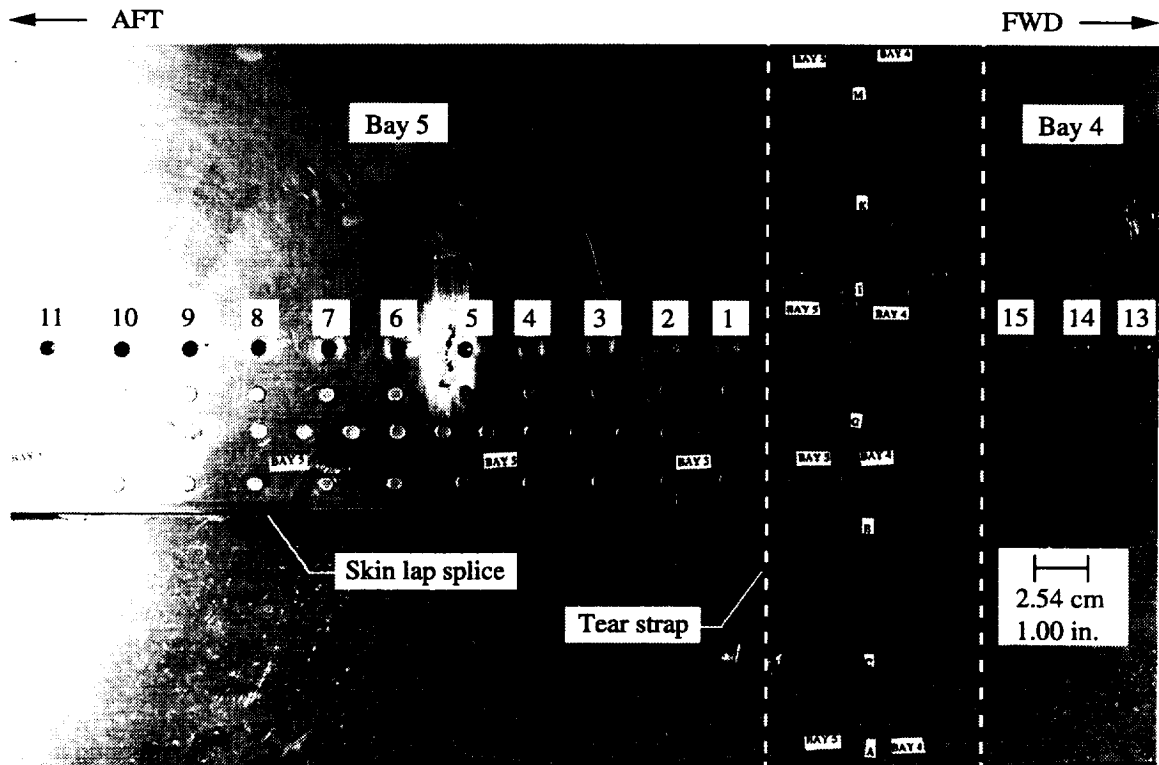
Figure 3.16 The photograph shows most of bay 5, the bay 4/5 tear strap region (marked by dashed lines), and a small portion of bay 4. Rivet rows are labeled with letters (right) from bottom to top (A through P) and rivet holes are numbered from forward to aft (right to left).

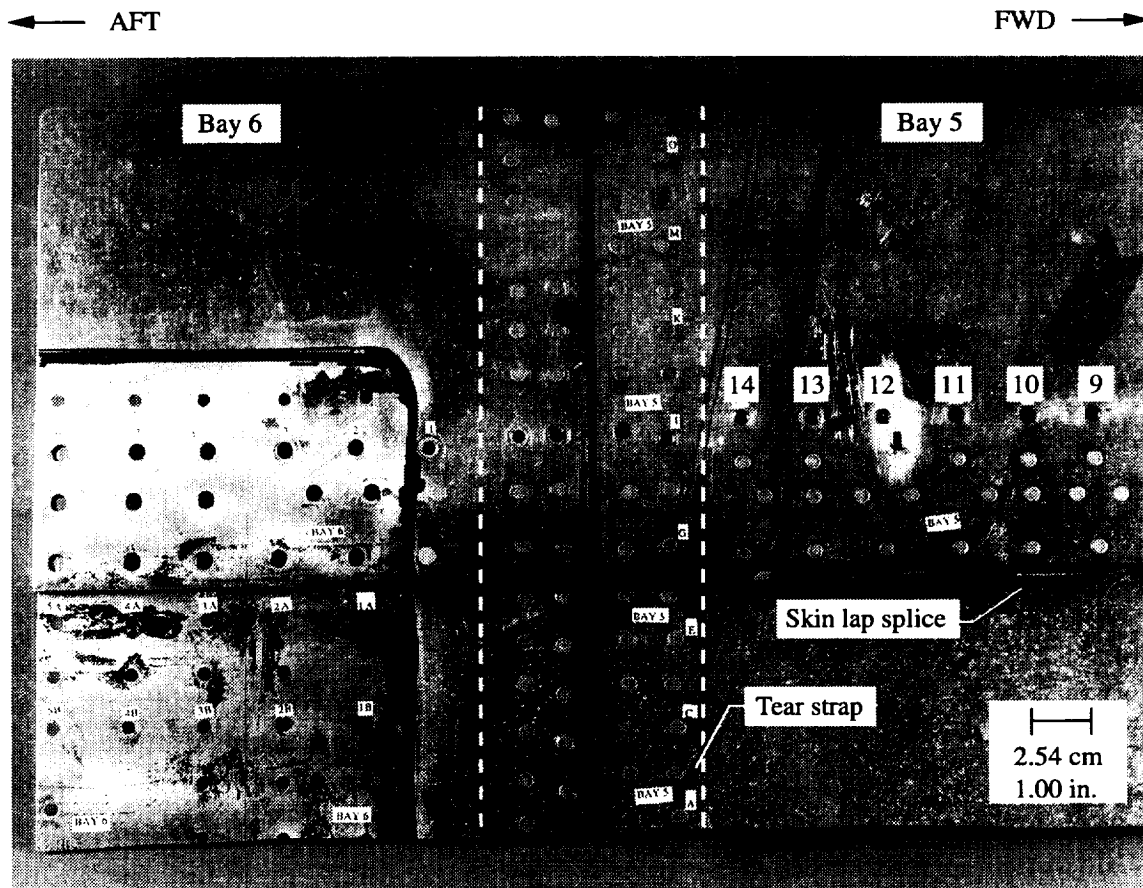
Figure 3.17 The photograph shows bay 6, the 5/6 tear strap region (marked with dashed lines), and a portion of bay 5. Rivet rows are labeled with letters (center) from bottom to top (A through P) and rivet holes are numbered from forward to aft (right to left).

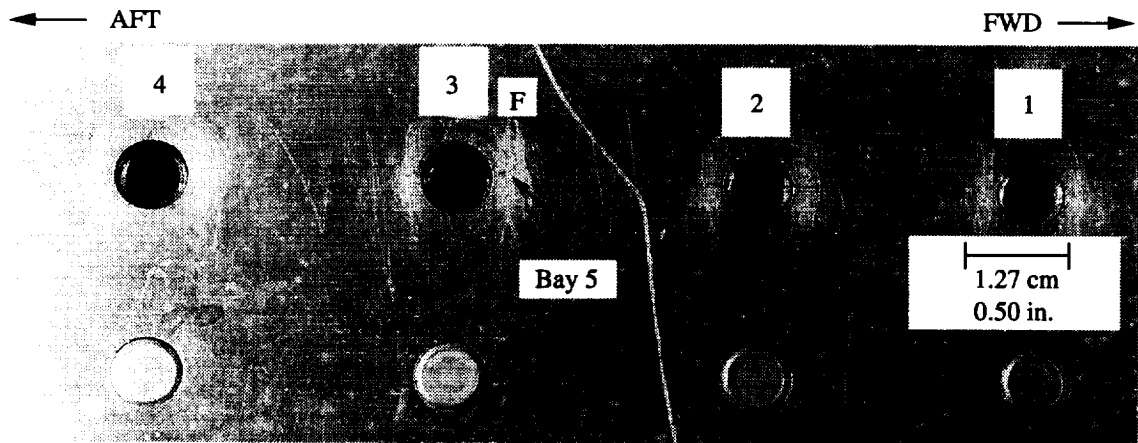
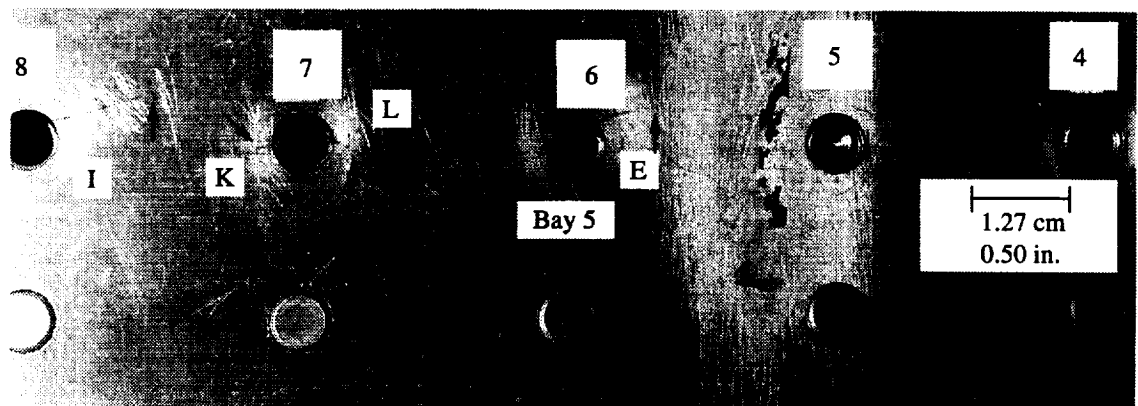
Figure 3.18 a) The photograph shows bay 5 upper rivet row holes 1 through 4. The position of the fatigue crack front, detected by *in situ* visual observation, is noted by an arrow at position F. b) The photograph shows bay 5 upper rivet row holes 4 through 8. The position of fatigue crack fronts, detected by *in situ* visual observations, are noted by arrows at positions I, K, L, and E.

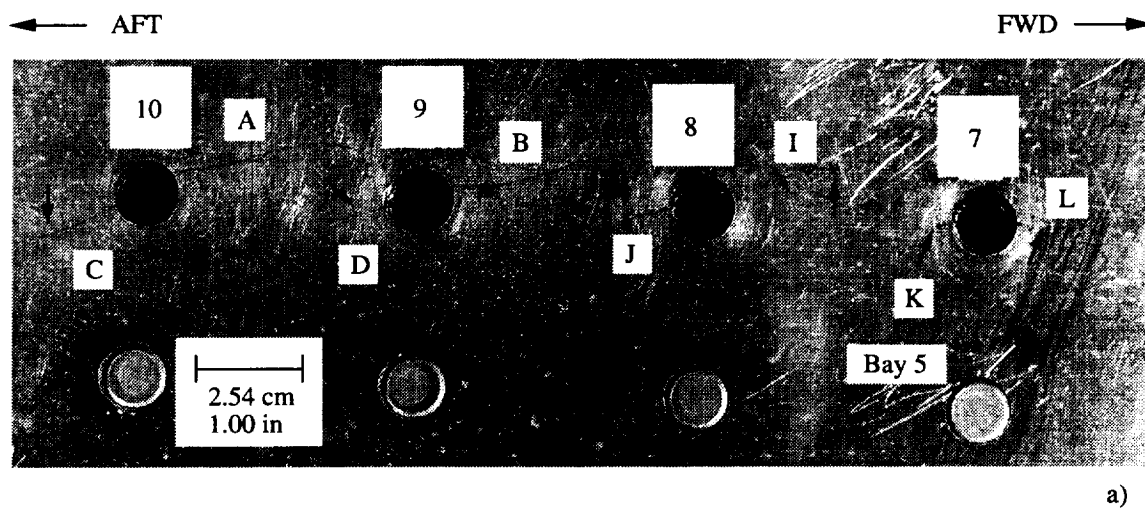
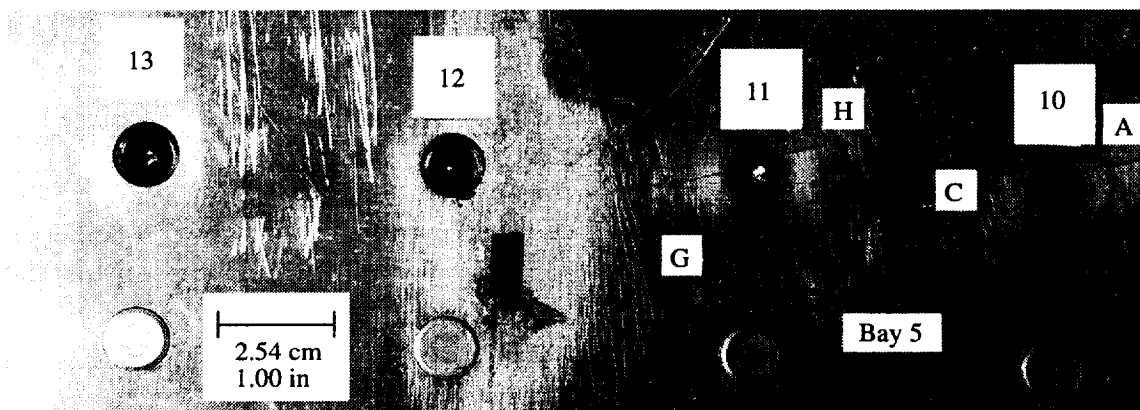
Figure 3.19 a) The photograph shows bay 5 upper rivet row holes 7 through 10. The position of fatigue crack fronts, detected by *in situ* visual observations, are noted by arrows at positions C, A, D, B, J, I, K, and L. b) The photograph shows bay 5 upper rivet row holes 10 through 13. The position of fatigue crack fronts, detected by *in situ* visual observations, are by arrows noted at positions G, H, C, and A.

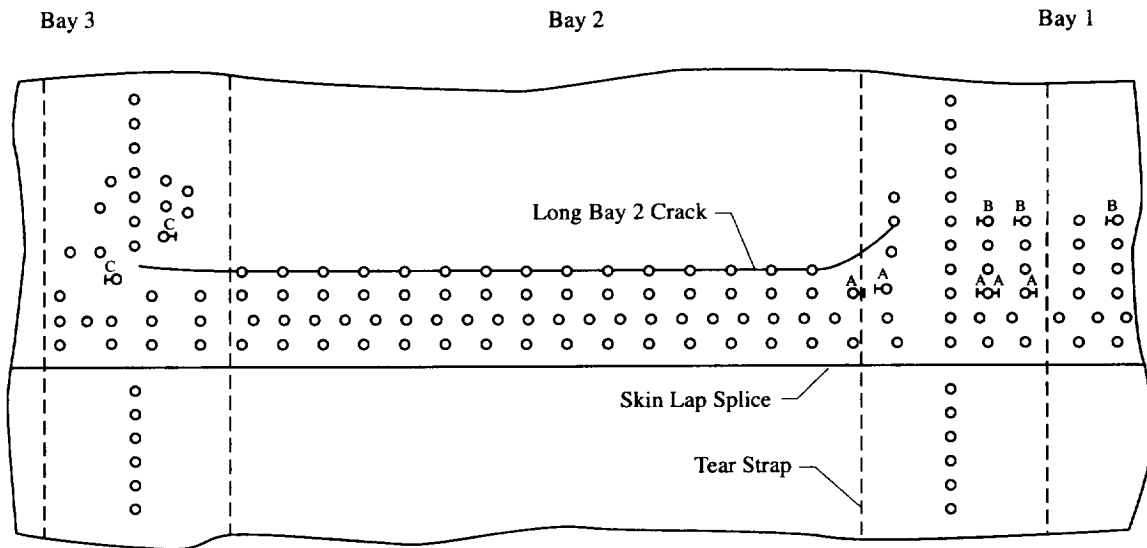
Figure 4.1 The schematic shows the location of possible cracks as detected by the eddy current inspection for the bay 2/3 T.S., bay 2 and the bay 1 T.S. regions. Dashed lines mark the tear strap regions. The long bay 2 crack (solid line) is shown in the upper rivet row of bay 2.

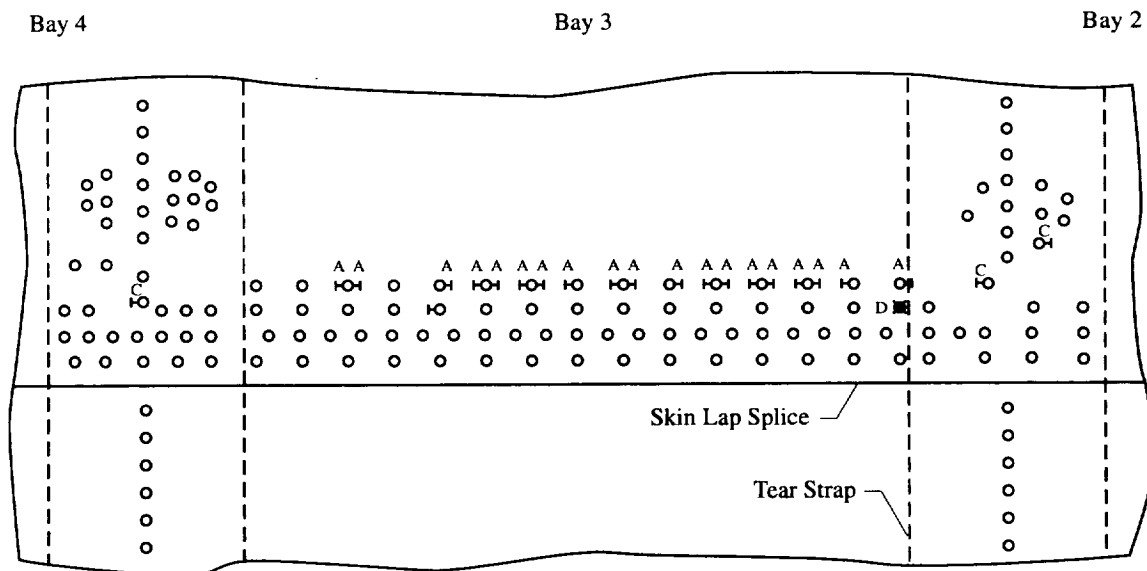
Figure 4.2 The schematic shows the location of possible cracks as detected by the eddy current inspection for the bay 3/4 T.S., bay 3 and the bay 2/3 T.S. regions. Dashed lines mark the tear strap regions.

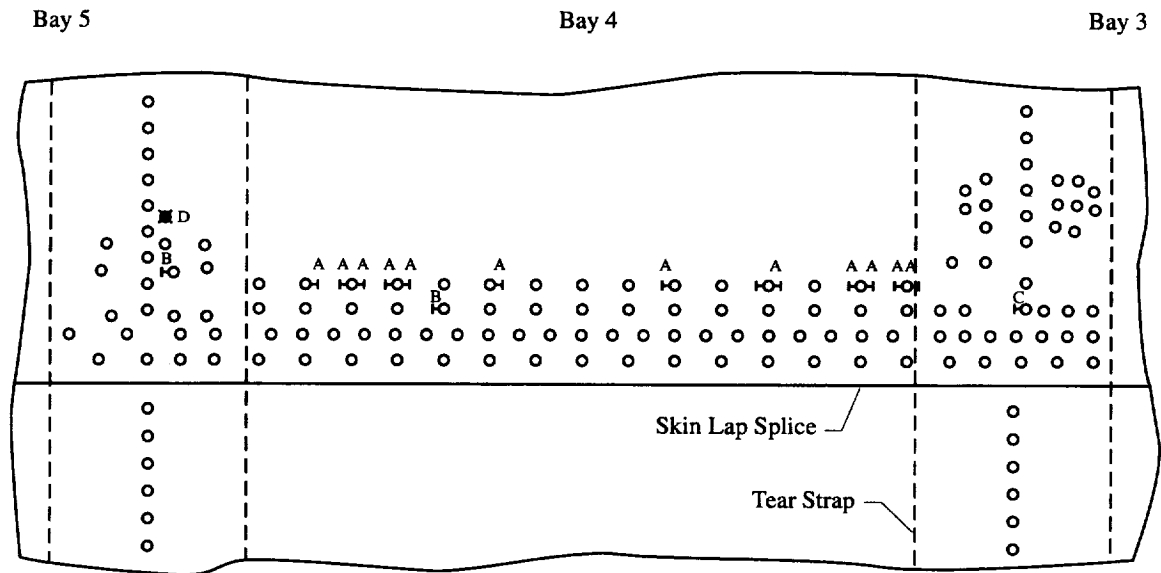
Figure 4.3 The schematic shows the location of possible cracks as detected by the eddy current inspection for the bay 4/5 T.S., bay 4 and the bay 3/4 T.S. regions. Dashed lines mark the tear strap regions. NDE was not performed on visible fatigue cracks.

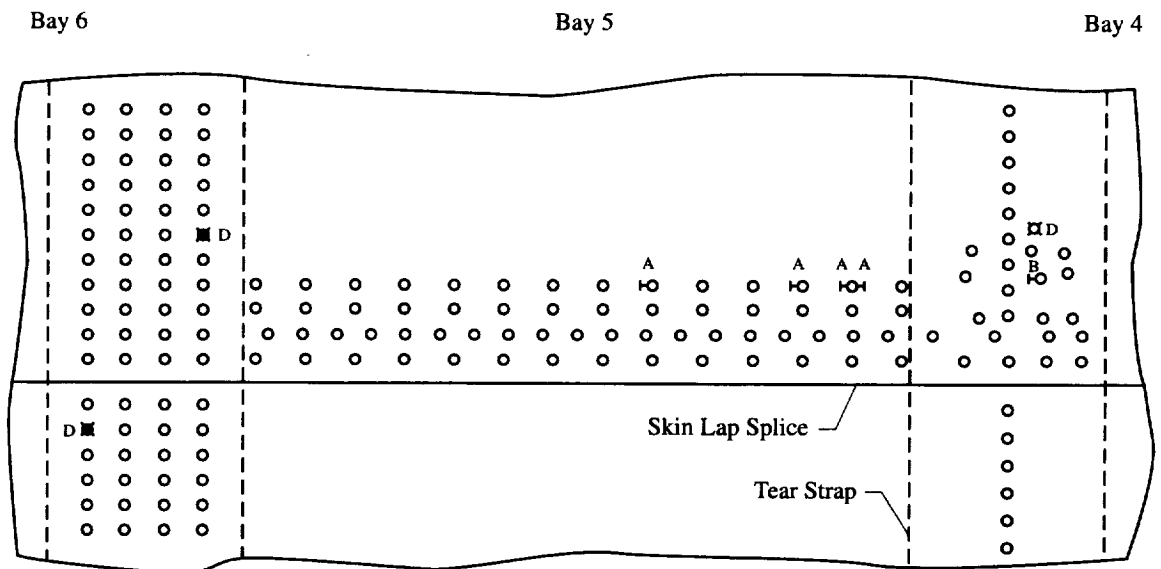
Figure 4.4 The schematic shows the location of possible cracks as detected by the eddy current inspection for the bay 6 T.S., bay 5 and the bay 4/5 T.S. regions. Dashed lines mark the tear strap regions.

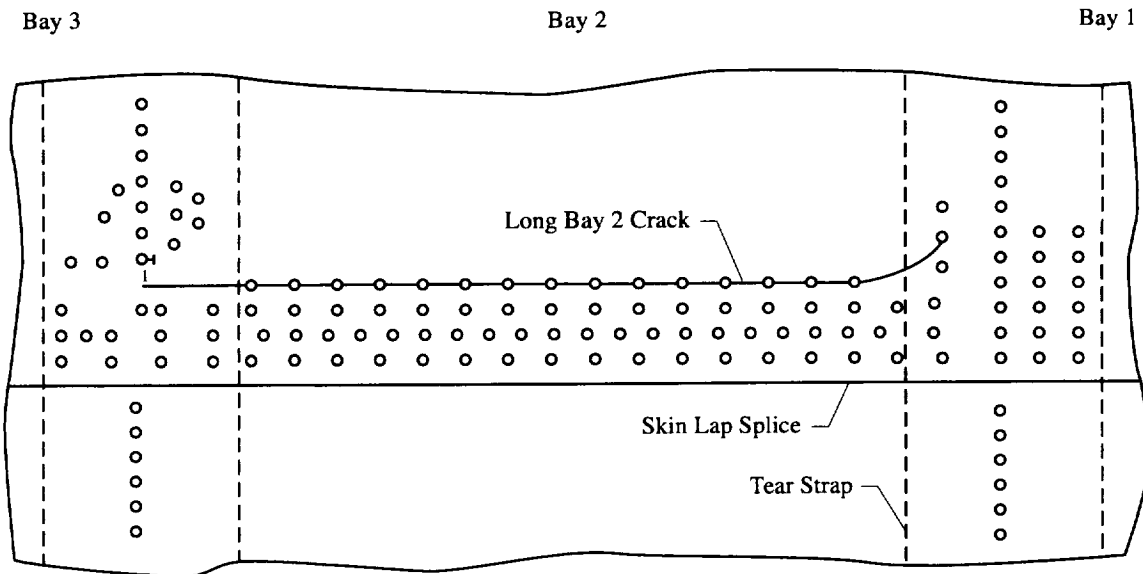
Figure 4.5 The schematic shows the location of possible cracks as detected by the X-ray inspection for the bay 2/3 T.S., bay 2 and the bay 1 T.S. regions. Crack indication #1 was found in the bay 2/3 T.S. The long bay 2 crack (solid line) is shown in the upper row of bay 2. Dashed lines mark the tear strap regions.

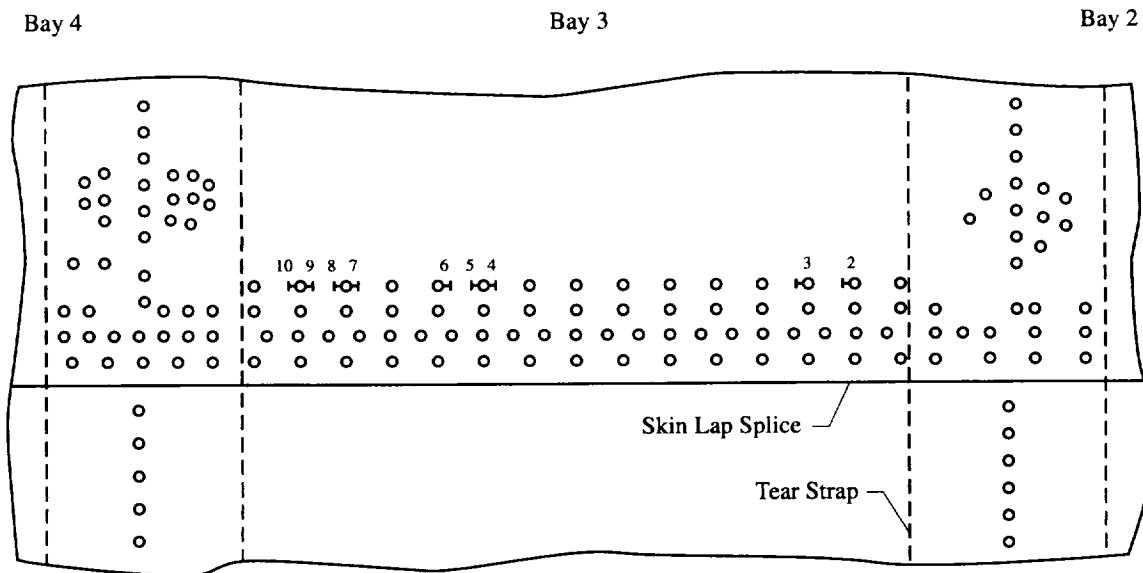
Figure 4.6 The schematic shows the location of possible cracks as detected by the X-ray inspection for the bay 3/4 T.S., bay 3 and the bay 2/3 T.S. regions. Cracks indications #4–10 were found in the upper rivet row of bay 3. Dashed lines mark the tear strap regions.
